NASA Contractor Report 159288

AIRCRAFT SURFACE COATINGS STUDY—VERIFICATION OF SELECTED MATERIALS

ENERGY EFFICIENT TRANSPORT PROGRAM

CONTRACT NAS1-14742, TASK 4.1.5
SEPTEMBER 1980

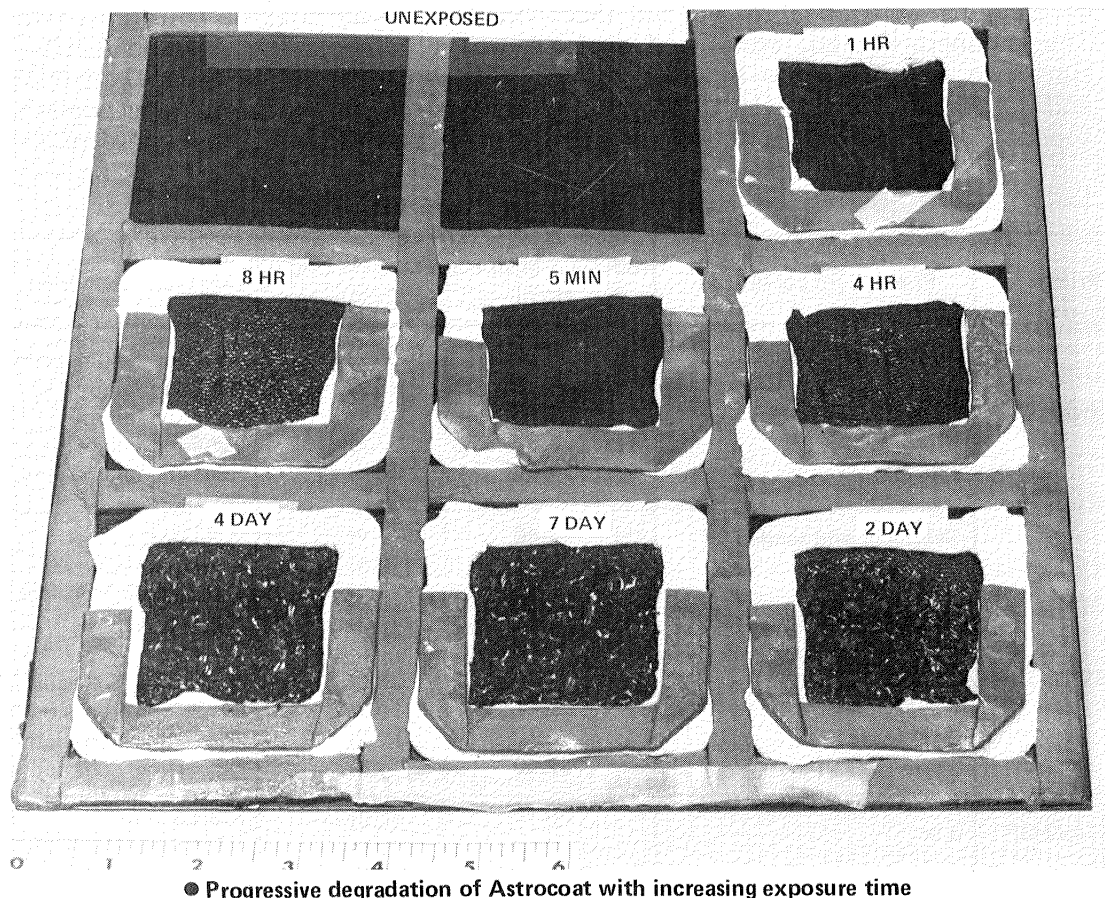
Figure 1. Panel Configuration for Skydrol Puddling Tests

● Progressive degradation of Astrocoat with increasing exposure time

The hydraulic fluid puddling tests are summarized in Table A-1 of Appendix A. Chemglaze M313 (coating No. 3) and Astrocoat (coating No. 5) were severely attacked after 5 minutes of exposure. All other coatings survived the 7-day fluid puddling but experienced a reduction in pencil hardness after most exposure periods, relative to the unexposed baseline. Coating No. 1 exhibited swelling. Panels topcoated with BMS10-60 did not exhibit visual evidence of deterioration. Coating No. 7 (BMS10-60 polyurethane enamel only) was included as a reference specimen. The post-test conditions of coatings No. 1 and 3 are shown in Figure 2 and that of coating No. 5 is shown in Figure 1.

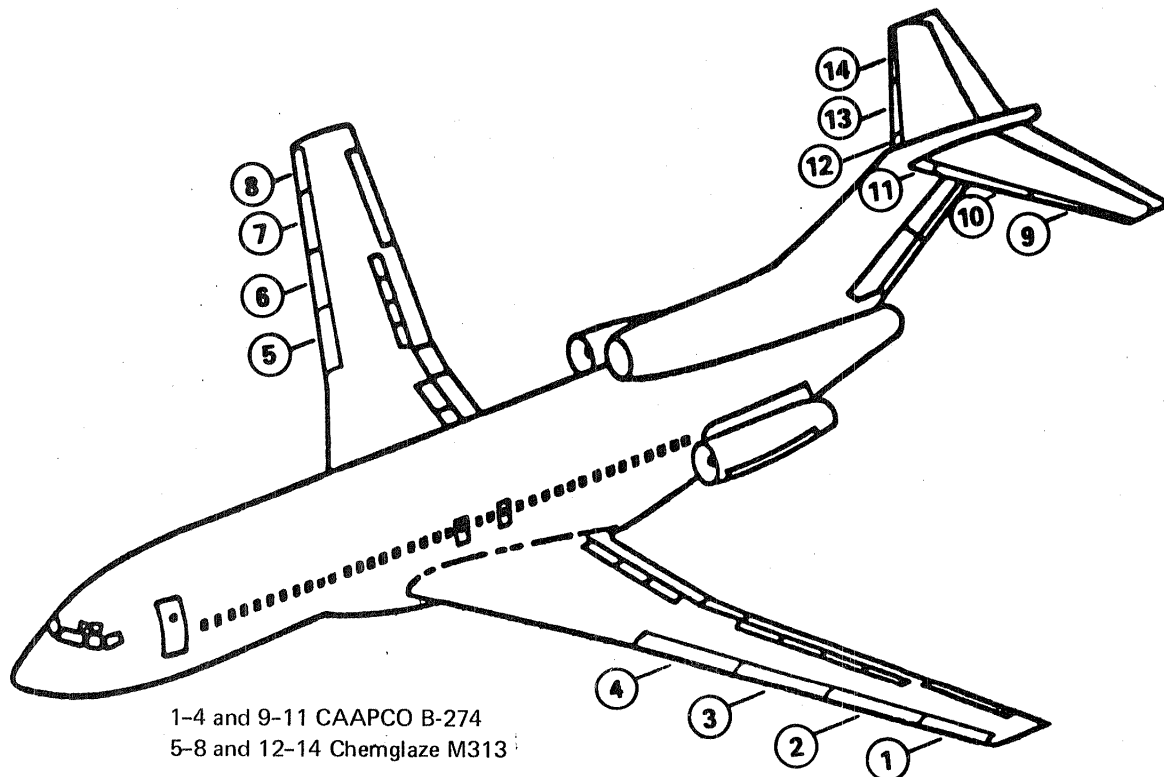
Figure 9. Coating Configuration on Continental Airlines 727

After curing for approximately 24 hours, an attempt was made to remove the masking tape. This resulted in edge lifting of the CAAPCO coating. The coatings were allowed to cure an additional 3 days and the remaining tape was removed using a knife at the edge of the tape where necessary.

The edge lifting indicated a poor bond near the edges of the coated area, therefore, the surface preparation procedure was modified for slats 2 and 7. On these slats, the area cleaned and alodined extended about 10 mm (0.4 in) beyond the edges of the area to be coated. After alodining, a second masking tape was applied to expose only the area to be coated. This ensured that the entire area was properly prepared. A good edge bond resulted, and the masking tape was removed without difficulty.

Different epoxy primers were used on the inboard and outboard halves of slat 2. At the end of the service evaluation, the coating was missing from the outboard half of that slat. This is discussed under Field Reports.

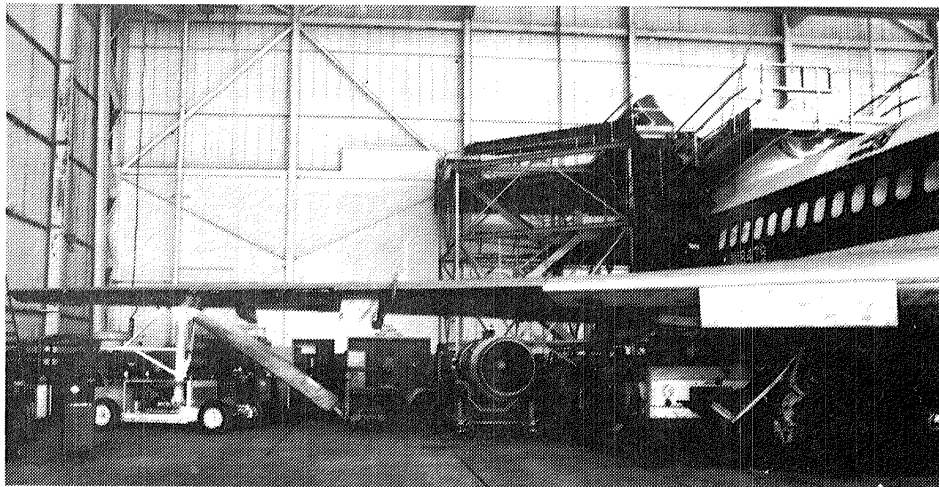
Figure 14. Airplane in Maintenance Hangar—Los Angeles

The flight service evaluation was concluded with return of the airplane to the CA maintenance base in Los Angeles on 22 November 1979 (fig. 14). The coatings had accumulated 3082 flight hours and 2421 landings. Contractor personnel inspected the airplane and made a photographic record of the condition of the coatings. A discussion of the findings follows on a per-item basis.

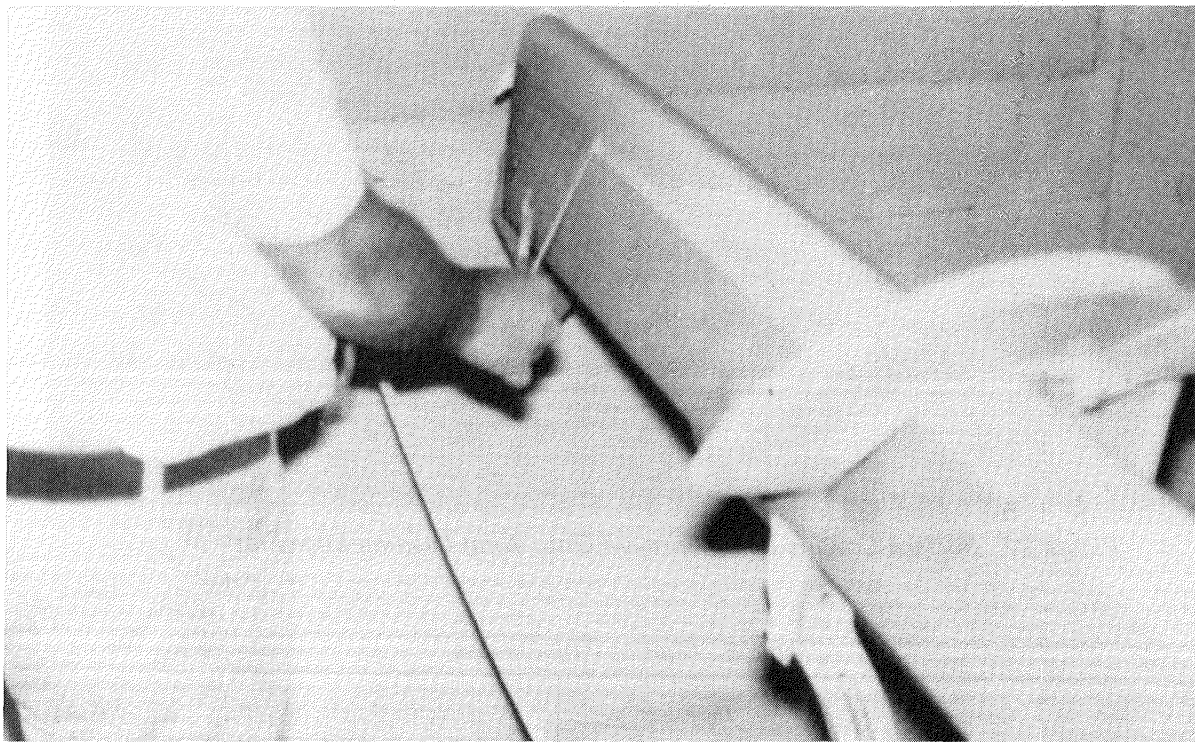
Figure 28. Method of Removing Masking Tape

Masking tape was removed from all parts within a few minutes of completion of the final coat, before a high film strength had developed. The tape was pulled in a direction about 45 deg from the surface and downward about 45 deg from the tape line, as shown in Figure 28. No edge-lifting of the coatings occurred when tape was removed in this manner.

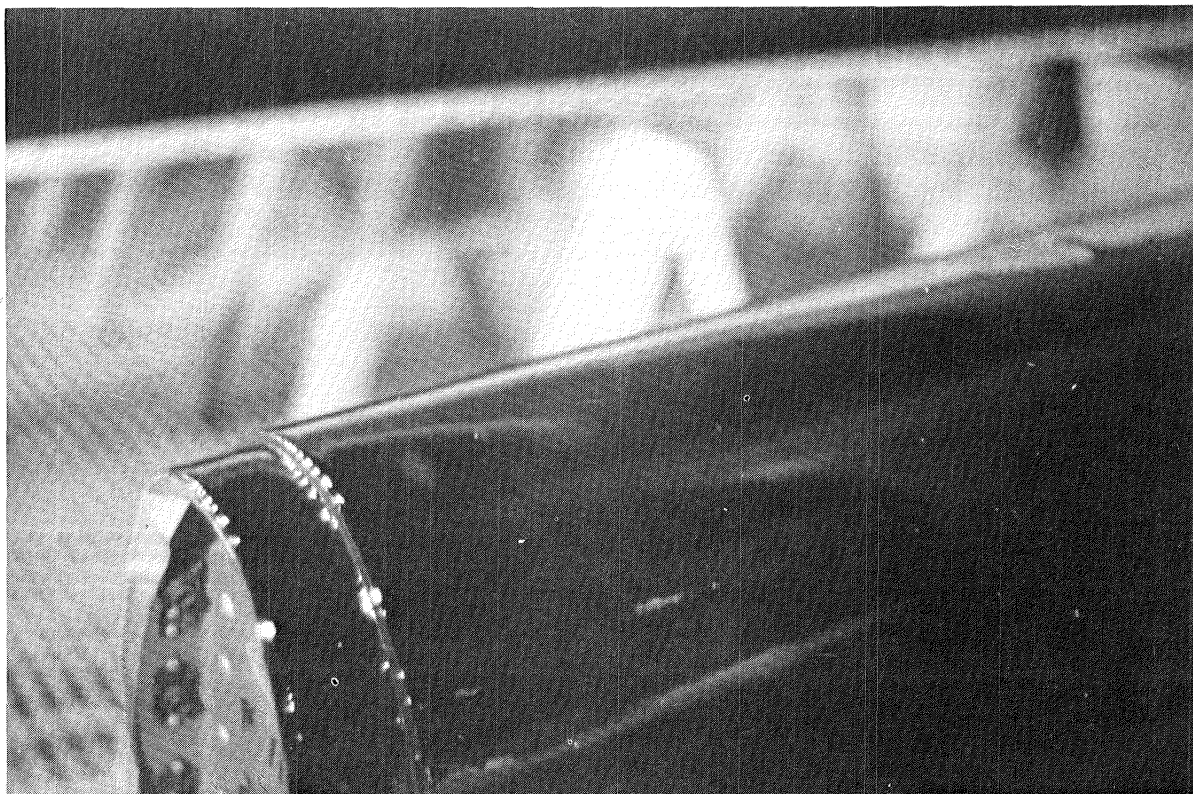
Figure 29. Horizontal Tail Leading Edge—Typical Smooth, Glossy Coating Surface

Figure 29 shows the end of one of the coated horizontal tail leading-edge sections after curing. The several small light spots are reflections from overhead lighting. The smooth, high gloss surface is typical of all the coated parts—a benefit from doing the work in the relatively clean atmosphere of a paint shop with controlled air circulation.
